June 1944 as Restricted Bulletin E4F23

CYLINDER-HEAD COOLING BY MEANS OF A SHIELD IN THE EXHAUST PASSAGE

By H. D. Wilsted and B. A. Mulcahy

Aircraft Engine Research Laboratory Cleveland, Ohio

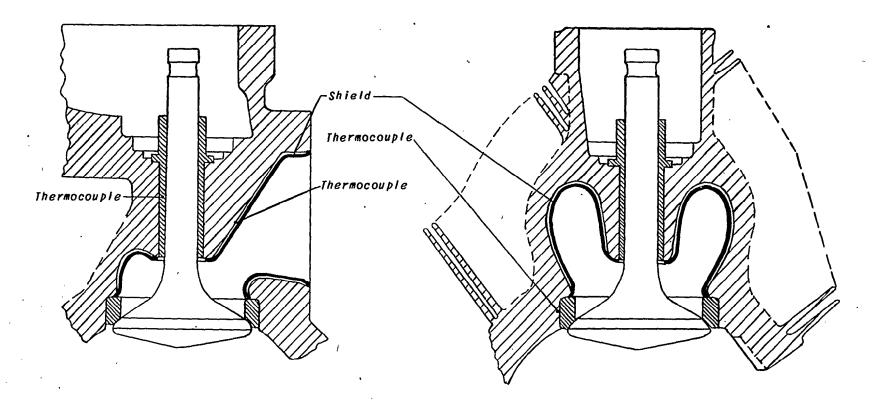
Figure 1. - Sections showing exhaust-passage shield and thermocouple locations.

Figure 2. - Diagrammatic layout of equipment.

An insulating shield (fig. 1) similar to the one described in reference 5 was fitted into the exhaust passage of a standard Wright C9GC cylinder. The shield, made of 1/16-inch sheet Inconel, was hand-formed in four pieces to fit and entirely cover the exhaust passage. The exhaust passage was covered with powdered asbestos held by porcelain insulating cement. The asbestos served to prevent contact of shield and cylinder-head material. The pieces of shield were gas-welded in place to form a one-piece shield. The edge of the shield near the insert of the exhaust-valve seat was then peened into a previously cut annular groove to make a gastight seal and to form a smooth surface. The opening in the shield through which the valve stem passed was sealed by peoning the shield against the exhaust-valve-guide boss. Gas leakage and lack of support at this point caused the eventual failure of the shield. The shield was not attached to the cylinder-head material except by peening into the groove near the insert of the valve seat and by forming tightly against the valve-guide boss and against the head material at the passage exit.

The cylinder, equipped with the exhaust-passage shield, was mounted on a single-cylinder crankcase. The cylinder bore was $6\frac{1}{8}$ inches and the crankshaft used had a stroke of 7 inches. The compression ratio was 6.7. The principal components of the test apparatus are shown diagrammatically in figure 2. Standard testengine equipment was used for measuring engine torque, engine speed, fuel consumption, cylinder temperatures, and fuel-air ratio. A separately driven centrifugal blower supplied the cooling air. Thermocouples were located in the exhaust-valve guide, near the seat insert, and in the exhaust-valve-guide boss (fig. 1).

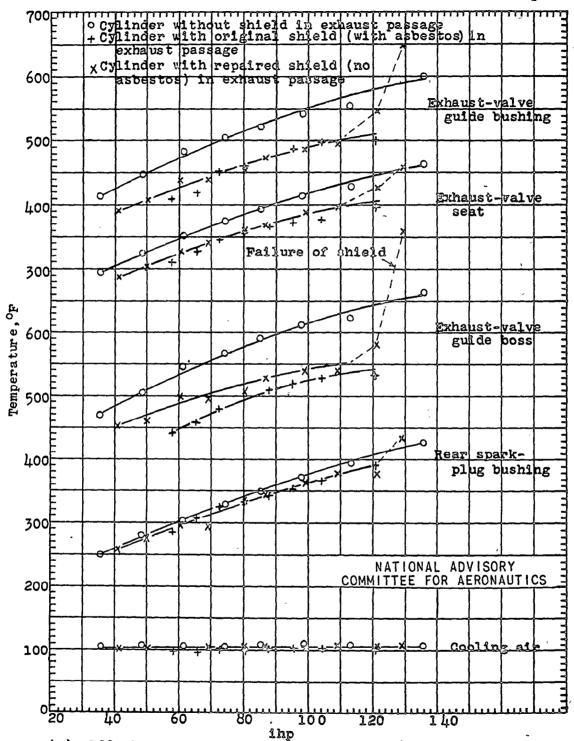
(a) Effect on measured temperatures.

Figure 3.- Effect of an exhaust-passage shield on the temperatures of the exhaust-valve seat, guide bushing, guide boss, and rear spark-plug bushing. Wright C9GC cylinder; fuel-air ratio, 0.08; engine speed, 2000 rpm; cooling-air pressure drop, 16 inches of water.

The exhaust-passage shield effectively lowered the temperatures of the exhaust-valve seat, the guide boss, and the guide bushing, as shown in figures 3 and 4. The temperature of the cooling air was higher when the cylinder was tested without the shield than during the tests with the shield; therefore, a correction to the observed cylinder temperatures was necessary. Data presented in figure 4 of reference 7 indicate that an increase of 1° F in the temperature of the cooling air will raise the temperature of the head approximately 0.8° F. The observed temperatures have been corrected to conform to a common cooling-air temperature on this basis and their variations with changes of power and with changes of cooling-air pressure drop $\sigma\Delta\rho$ are shown in figures 3(b) and 4(b), respectively, where $\sigma\Delta\rho$ is equal to the static-pressure drop of cooling air multiplied by the ratio of the average density of the cooling air to the density of air at a pressure of 29.92 inches of mercury and a temperature of τ 00 F.

Figure 3 shows that the temperatures of the valve seat and the guide bushing were approximately the same with the original shield which had asbestos behind it and with the repaired shield which had no asbestos. The valve-guide boss, however, was hotter without asbestos, perhaps because the shield touched the boss near the thermocouple. The effect of the shield failure is shown in figure 3 by the sudden rise in temperatures. The extremely high temperatures are probably due to gases, guided by the broken shield, that impinged on the valve-guide boss and passage wall.

The tests with variable power (fig. 3) were run with a cooling-air pressure drop Δp of 16 inches of water. With a pressure drop of this magnitude, additional quantities of cooling air are comparatively ineffective in reducing cylinder temperatures; therefore, if the temperature reduction effected by the use of the shield were to be accomplished by increasing the cooling-air flow, extremely high pressure drops would be required. The tests with variable cooling-air pressure drop were run at 91 indicated horsepower; the results are shown in figure 4. The following table shows values of cooling-air pressure drop Δp in the operating range that would give equal temperatures with and without the shield.

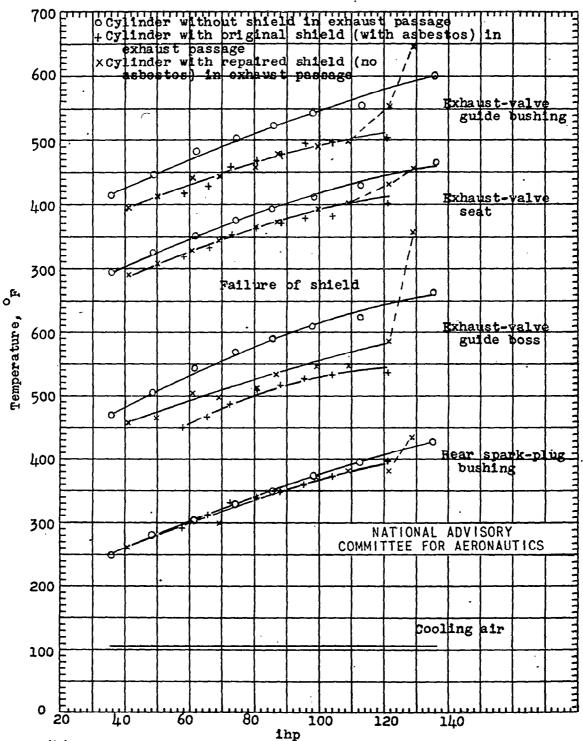
(b) Effect on corrected temperatures.
Figure 3.- Concluded. Effect of an exhaust-passage shield on the temperatures of the exhaust-valve seat, guide boss, and rear sparkplug bushing. Wright C9GC cylinder; fuel-air ratio, 0.08; engine speed, 2000 rpm; cooling-air pressure drop, 16 inches of water.

Figure 3(b) shows that the following reductions in corrected temperatures resulted from the use of the shield: that of the valve-guide bushing was reduced 48° F, from 530° F to 482° F; that of the valve seat was reduced 24° F, from 404° F to 380° F; that of the guide boss was reduced 82° F, from 599° F to 517° F, when the shield was first installed, and 57° F, from 599° F to 542° F, after the shield had been repaired; that of the rear spark-plug bushing was reduced 8° F, from 361° F to 353° F.

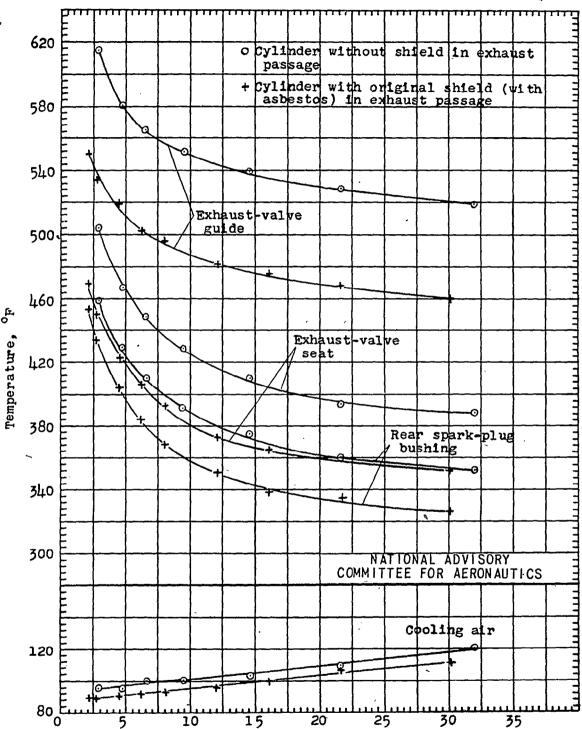
Cooling-air pressure drop, Ap, in. water
(a) Effect on measured temperatures.

Figure 4.- Effect or variation in cylinder-head cooling on the temperatures of the exhaust-valve guide, valve seat, and rear spark-plug bushing. Wright C9GC cylinder; fuel-air ratio, 0.08; engine speed, 2000 rpm; power output, 91 indicated horsepower.

Cooling-air pressure drop required, GAp (in. H ₂ O)	
	With shield	Without shield
Corrected guide temper- ature, 530° F	3	22
Corrected seat temper- ature, hhl F	3	7計

- 2. At 91 indicated horsepower the use of the shield reduced the temperature of the exhaust-valve guide the same amount as increasing the cooling-air pressure drop from 3 to 22 inches of water. The cooling-air pressure drops required for equal temperatures of the valve seat at this power were 3 inches of water with the shield and $7\frac{1}{1}$ inches of water without the shield.

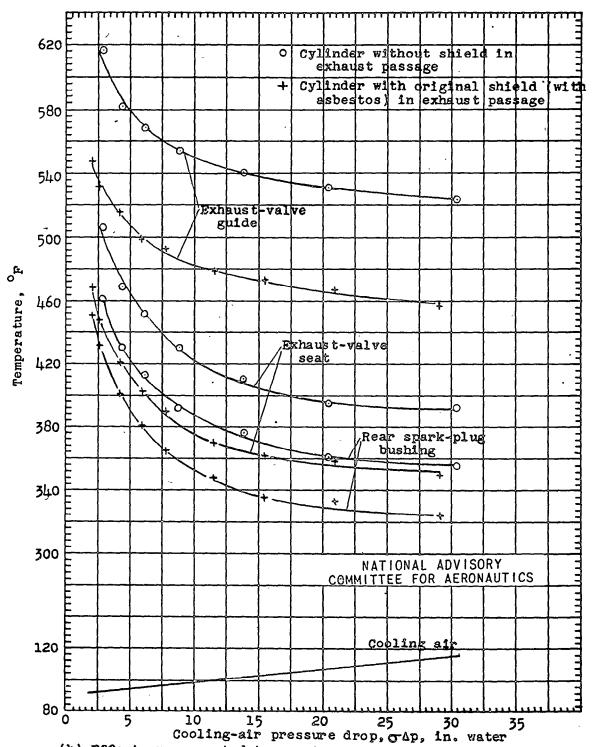
(b) Effect on corrected temperatures.
Figure 4.- Concluded. Effect of variation in cylinder-head cooling on the temperatures of the exhaust-valve guide, valve seat, and rear spark-plug bushing. Wright C9GC cylinder; fuel-air ratio, 0.08; engine speed, 2000 rpm; power output, 91 indicated horsepower.

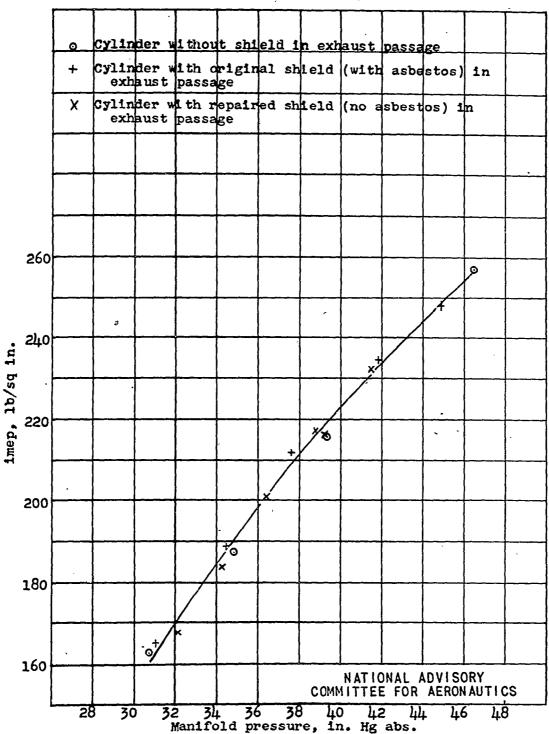
Figure 5.- Relation between manifold pressure and indicated mean effective pressure with and without exhaust-passage shield. Wright C9GC cylinder; fuel-air ratio, 0.08; engine speed, 2000 rpm; cooling-air pressure drop, 16 inches of water.

Figure 5 shows that the shield in the exhaust passage did not sufficiently impede the flow of exhaust gas to cause a perceptible reduction in engine power. No difference in the manifold pressure required for a given indicated mean effective pressure, with or without the shield, is apparent.

- 3. The exhaust-passage shield did not sufficiently obstruct the passage of exhaust gases to cause a perceptible reduction in the power of the engine.
